# SIMULTANEOUS ASSESSMENT OF COTTON YIELD MONITORS

G. Vellidis, C. D. Perry, G.C. Rains, D. L. Thomas, N. Wells, C. K. Kvien

**ABSTRACT.** The most essential component of precision farming is the yield monitor — a sensor or group of sensors installed on harvesting equipment that dynamically measures spatial yield variability. Yield maps, which are produced with data from yield monitors, are extremely useful in providing a visual image to clearly show the variability of yield across a field. In response to the demand for a reliable and accurate cotton yield monitor, several have recently become commercially available. We assessed the AgLeader, Agri–Plan, FarmScan, and Micro–Trak cotton yield monitors in southern Georgia for five harvest seasons from 1997 to 2001. During 2001 we also assessed a prototype yield monitor. Each year, two or more yield monitors were mounted on a cotton harvester and were used during the harvest of several farmer–owned and managed fields. The accuracy of each yield monitor was tested by comparing the weight of each harvested load to data produced by the yield monitor. Yield maps from each yield monitor were also produced with the respective software pack

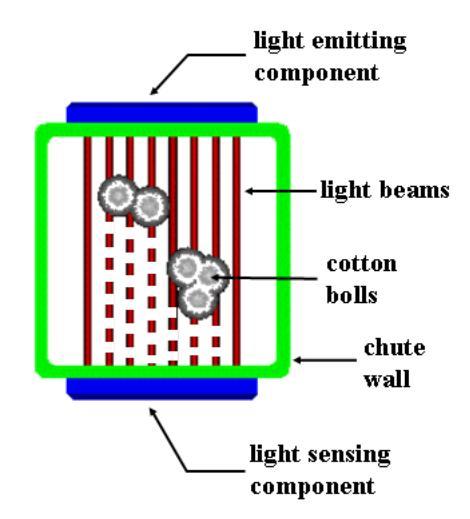
Figure 1. Schematic showing the operation of an optical yield monitor.

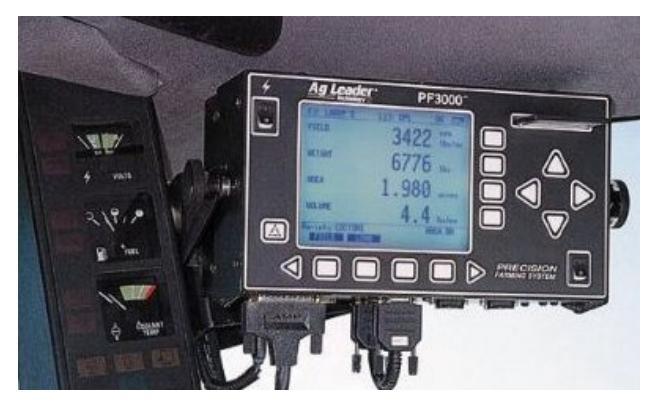
Figure 2. The AgLeader PF3000 user interface console.

The standard PF3000 console (fig. 2) required installation of new cotton firmware that prevented the operator from using the console for other purposes until the initial firmware was reestablished. The PF3000 allows the operator to view harvest variables such as current yield, total load, current ground speed, area harvested, etc., to select Field and Load identifiers, to set system settings, and to perform system diagnostics. The AgLeader console had membrane function buttons and a multi–line, back lit, easily read liquid crystal display (LCD). The AgLeader SMS Basic version 1.00 software was used to process the yield data. The SMS software provided for mapping, archiving, report generation, etc.

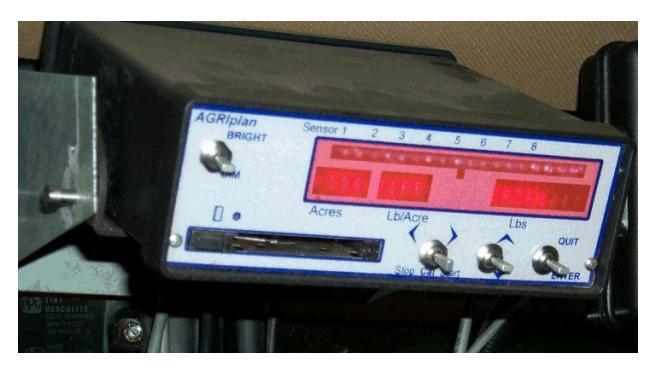
Figure 4. Agri–Plan 600 user interface console with the three toggle switches (lower right).

The 2000 harvest season version of the system consisted of an Agri–Plan 600 cab–mounted user interface console (shown in fig. 4) that had three toggle switches and a three–window, single–line light emitting diode (LED) display. The console provided the following information during harvest: current yield, total pounds, acres harvested, field identifier, and sensor diagnostics. Field identifiers could be changed but the console offered no way to separate loads. The system required the use of an Agri–Plan 8–channel GPS receiver but also required an external RTCM (differential) correction signal. Agri–Plan software was used to process and map the yield data. The software was required to initialize/format the PCMCIA data cards (table 1).

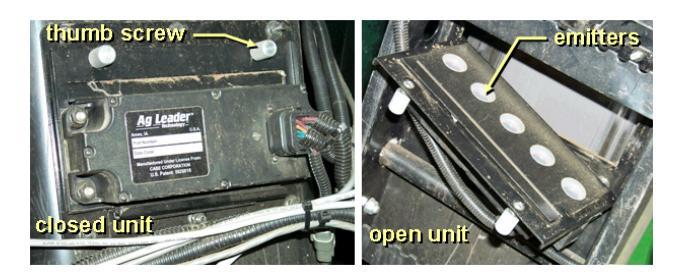
Figure 3. 2000 version of the AgLeader yield monitor sensors mounted on the front of a chute. This sensor has five photo detectors.

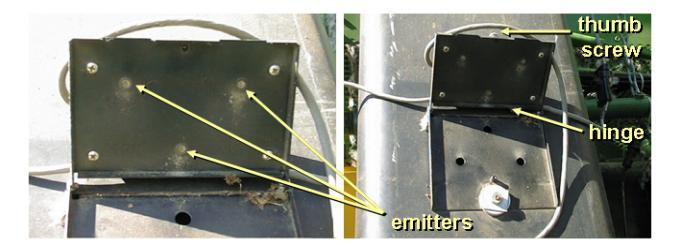
Figure 5. Agri–Plan sensor mounted on the front side of a cotton picker chute. The sensor is in the open position for inspection.

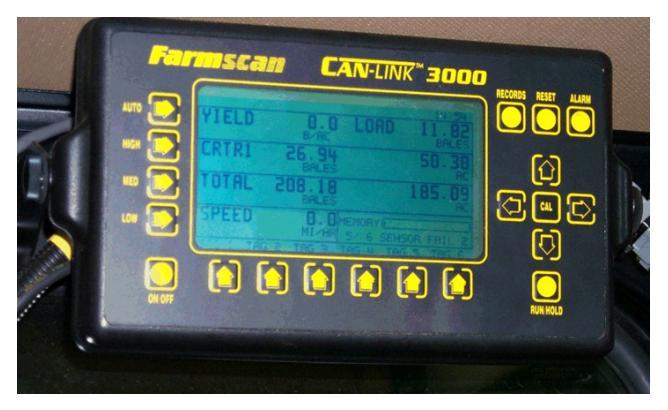
Figure 6. FarmScan Can-Link 3000 user interface console.

The Can–Link 3000 console (fig. 6) allowed the operator to view harvest variables such as current yield, total load, current ground speed, area harvested, etc., to select Field identifiers (referred to as "trips"), to set system settings, and to perform system diagnostics. Field identifiers could be changed but the console offered no way to separate loads. The FarmScan console had membrane function buttons and a multi–line, easily read back–lit LCD display. The Computronics FarmScanDM software was used to process and map the yield data. The software was also required to initialize/ format the PCMCIA data cards (table 1).

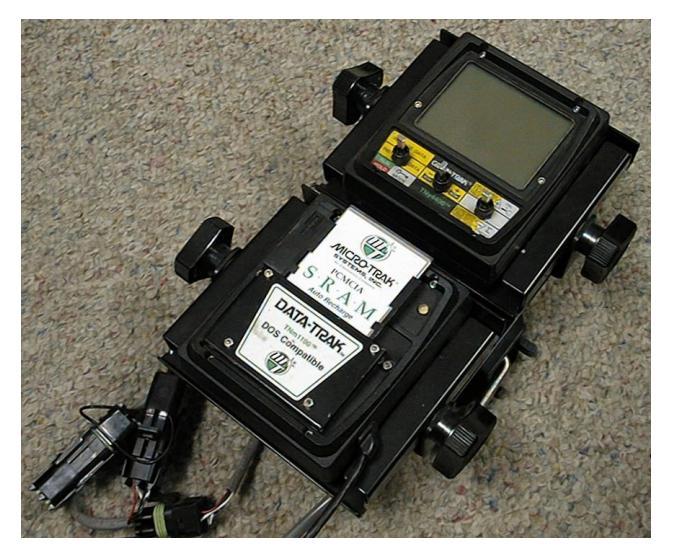
Figure 8. Micro–Trak user interface console with the Grain–Trak (top) and Data–Trak (bottom) modules.

The Grain–Trak featured a backlit LCD display of various harvest parameters such as load, field, and season counters, current or average yield, number of rows being harvested, setup and calibration parameters, including sensor check,

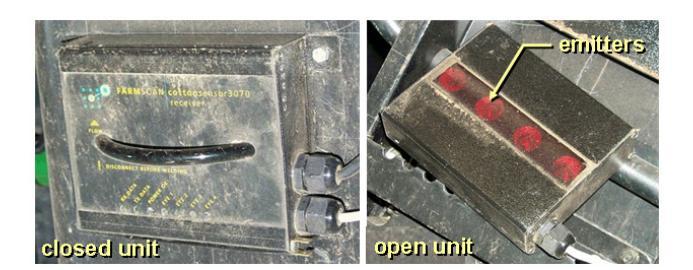
Figure 7. 2000 version of the FarmScan sensor mounted on the front of a cotton picker chute.

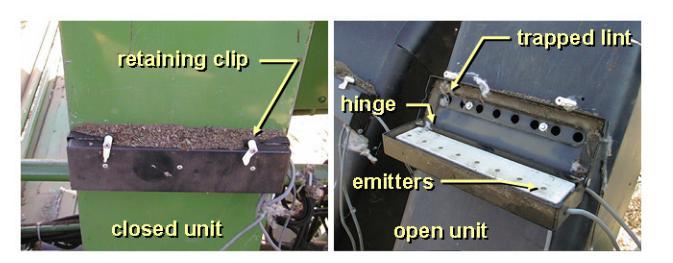
Figure 9. Micro–Trak sensor installed on the front of a cotton picker chute.

The most visible Micro–Trak changes were to the mounting brackets used for the sensors. The new design (fig. 9) allowed the sensors to be inspected and cleaned when needed. Internally, the Micro–Trak system was also upgraded to correct power supply problems that were occasionally observed during 1997. An entirely upgraded Micro–Trak system was installed prior to the 1998 harvest season. Both the Agri–Plan and Micro–Trak software packages were upgraded.

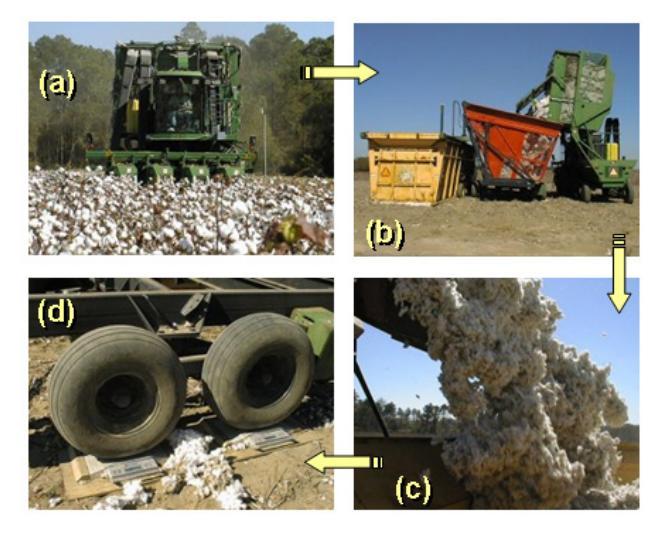
Figure 10. Field procedure used to obtain accurate yield values for each harvested basket load during the 1998–2001 harvest seasons consisted of harvesting (a), emptying into the boll buggy (b and c), and weighing the load (d).

The performance of the two yield monitoring systems was compared on three fields harvested in September and October of 1998. To monitor the performance of the yield monitors on a per–load basis, each basket–load harvested by the cotton picker was weighed in the boll buggy with the wheel load scales (fig. 10).

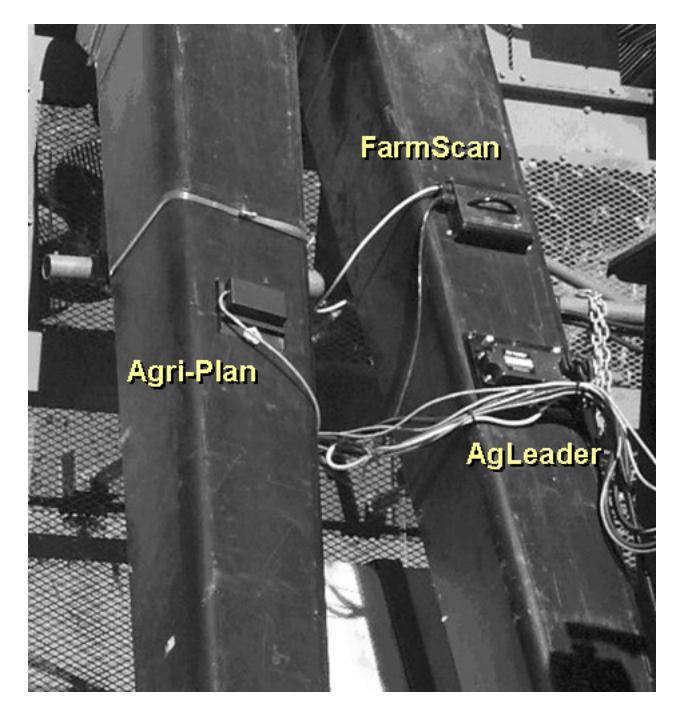
Figure 11. Configuration of the three sensors mounted on chutes 3 and 4 of the UGA John Deere 9965 cotton picker during the 2000 harvest season.

Prior to the 2000 harvest season Agri-Plan and FarmScan upgraded their systems. The 2000 FarmScan flow sensors appeared vastly improved over the 1999 models. They were easy to install and appeared robust. No changes were made to the Micro-Trak system by the manufacturer since it was last upgraded in 1998 so we chose to remove the Micro-Trak system from the UGA picker and replace it with the newly available AgLeader yield monitoring system. Because of licensing restrictions, AgLeader was only available for commercial use on Case cotton pickers. However, we were able to purchase a system from AgLeader for research purposes. This system, like the FarmScan, required sensors on only two of the four air chutes. It was installed on chutes 1 and 3. Agri-Plan offered upgraded sensors for 2000, which we purchased and installed on two chutes. So, for the 2000 harvest season, the UGA picker was equipped with two Agri-Plan sensors (chutes 2 and 4), and two AgLeader and two FarmScan sensors both installed on chutes 1 and 3 (fig. 11). All sensors were installed front-to-back on the chutes.

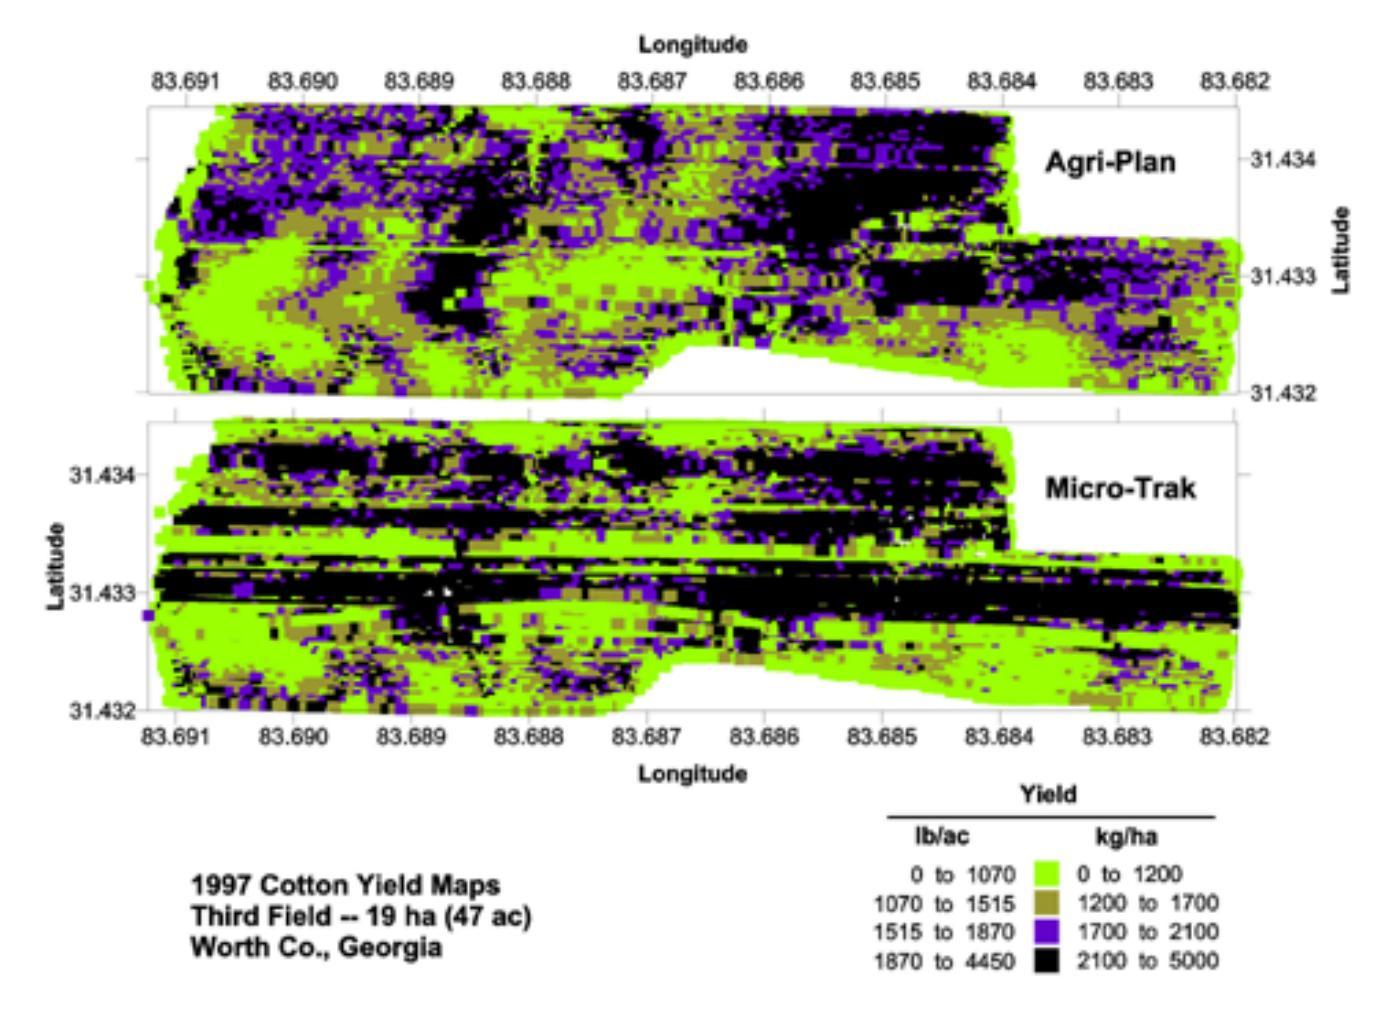
Figure 12. Agri-Plan and Micro-Trak yield maps from the third field [19 ha (47 acre)] harvested during 1997.

Data from the third field [19 ha (47 acre)] was used to create yield maps (fig. 12) and assess the Agri-Plan and Micro-Trak systems. The Agri-Plan system had few operational problems while harvesting this field. Daily errors were small and their absolute values averaged 1.7%. The percent difference in total actual yield and total Agri-Plan estimated yield was -0.9% (table 3). Actual yield data were collected by weighing unloaded and loaded cotton trailers at a nearby peanut buying point equipped with certified scales. Consequently, we were not able to segregate the cotton into basket loads for weighing. Yield variability was visually observed prior to harvest and appeared related to soil type, drainage, and topography. The Agri–Plan map (fig. 12) seems to better represent the observed variability. In addition, the patterns shown in the yield map were also observed in a bare-soil photograph of the field in which soil types are easily distinguished.

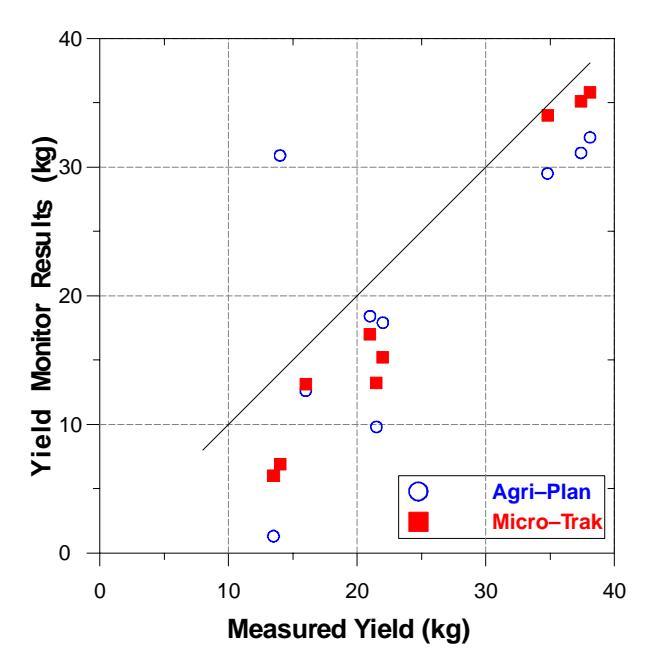
Figure 13. Comparison of yield monitor data to yield measured by weighing bagged cotton in field plots. The diagonal line represents 1:1 agreement (conversion: multiply kg by 2.2 for lb).

underestimated yields by 22.8 and 22.4%, respectively. Because the plots were only 33 m (108 ft) long, the data may have been overly impacted by an edge effect caused by systems' data smoothing algorithms — both during calibration and during harvest. An additional reason to suspect edge effects is the high correlation between the yield monitor data and bagged cotton weights – 99% for Micro–Trak and 95% for Agri–Plan (without the outlier). The edge–effect explanation could not be verified as the algorithms used by the manufacturers to estimate yield are proprietary. Overall, the plot experiment did not provide the anticipated assessment on instantaneous accuracy of the systems.

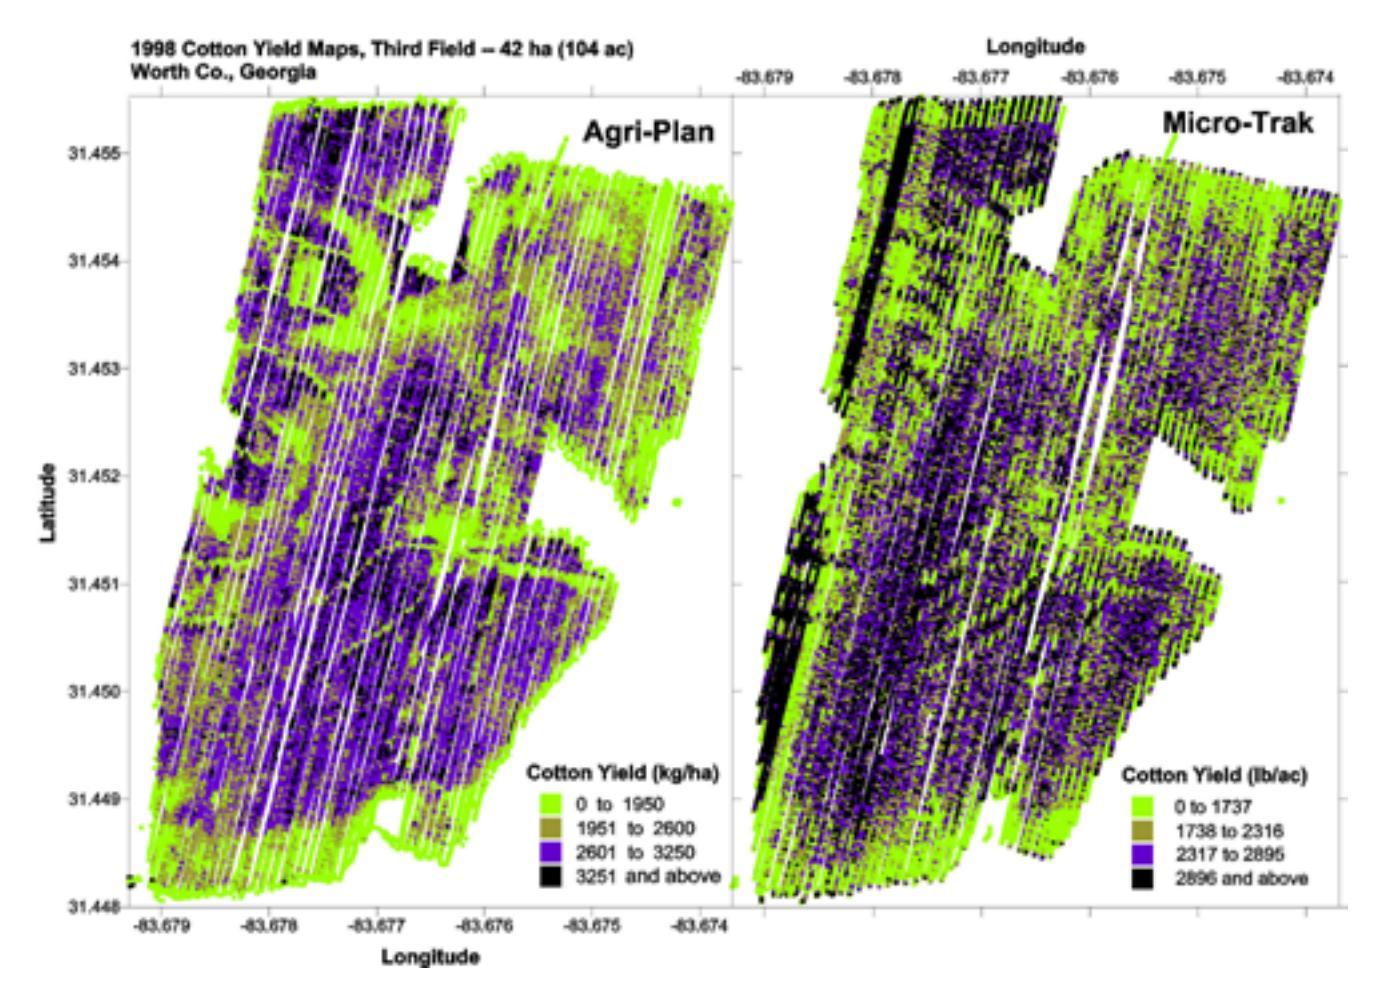
Figure 14. Yield map of the third field [42 ha (104 acre)] harvested during 1998 created with the Agri–Plan (left) and Micro–Trak (right) system data. The semicircular patterns in the Agri–Plan map were caused by tracks of the field's center pivot irrigation system.

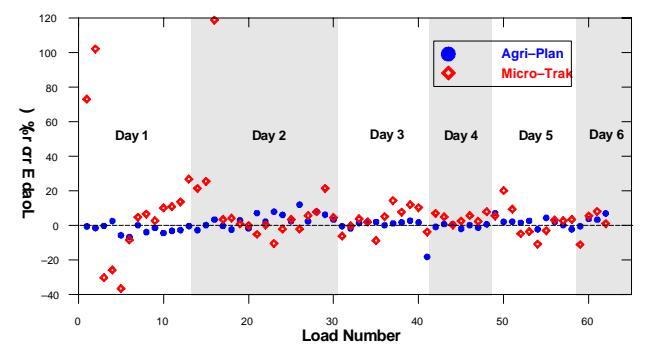
Figure 15. Percent errors of the load-by-load comparisons from the third field harvested during 1998.

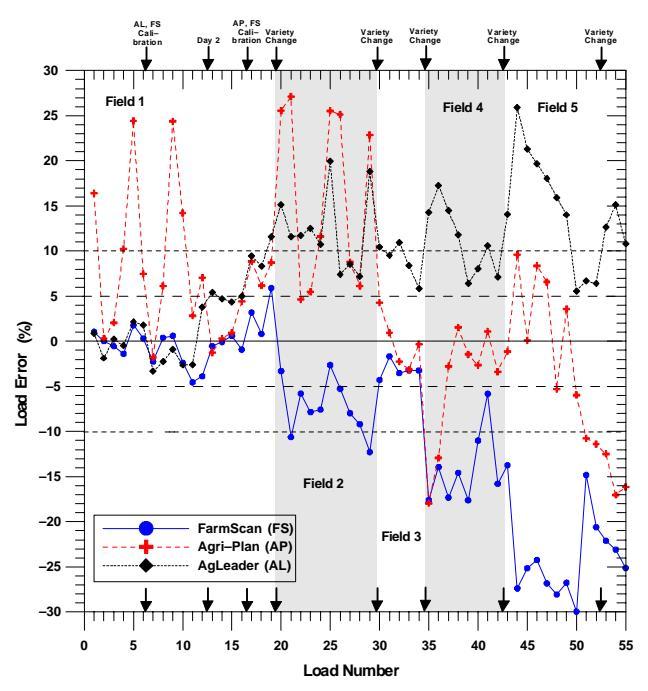
Figure 16. Percent load error of each load measured for the three yield monitoring systems used during the 2000 harvest season.

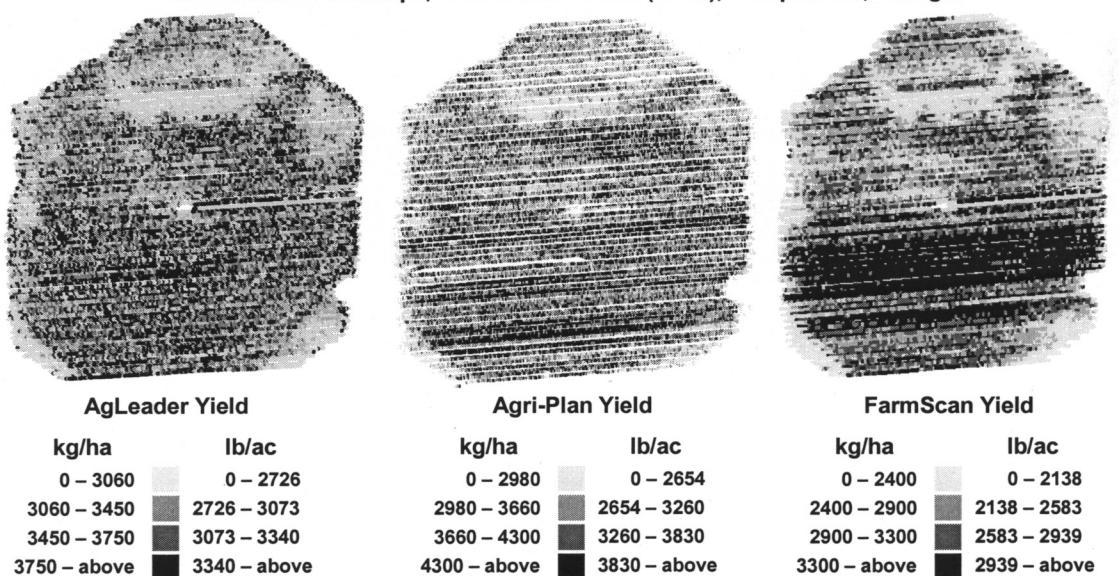
2000 Cotton Yield Maps, First Field – 14 ha (35 ac), Colquitt Co., Georgia

Figure 17. AgLeader (left), Agri-Plan (center), and FarmScan (right) yield maps of the first field [14 ha (35 acre)] harvested during 2000.

Pivot tracks are visible in both the Agri-Plan and AgLeader maps. FarmScan was not as responsive, perhaps as a result of more smoothing algorithms. The FarmScan map also appears slightly distorted. Although we were not able to identify the cause of the distortion, we suspect it is a function of the software code that processes and plots the GPS coordinates. The changes in accuracy evident in each of the three systems could be the unique response of each system's sensors to an ever-changing environment. Our results suggest that all three systems might have benefitted from re-calibration in fields where the cotton crop was substantially different from the crop that was used for initial calibration. These differences could be variety, irrigation, yield levels, defoliation quality, etc. all of which change frequently in most areas of the Cotton Belt. Nevertheless, the maps still displayed spatial yield trends. It must be made clear to farmers that yield monitor performance is directly related to frequency of calibration and maintenance.

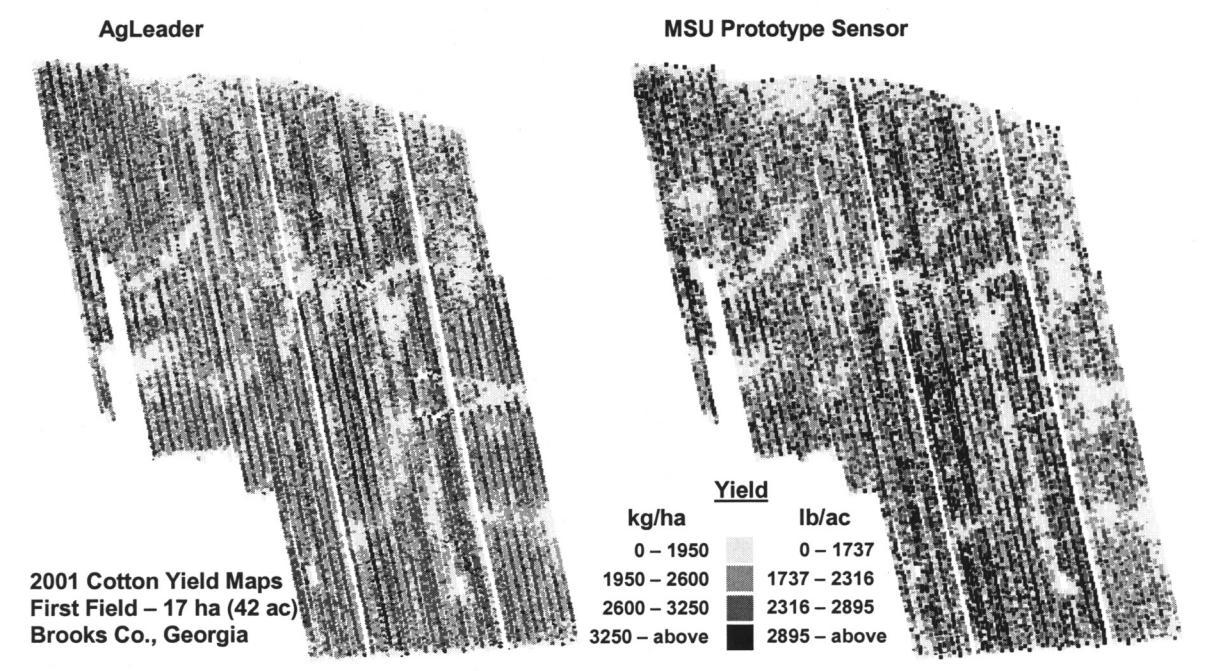
Figure 18. 2001 yield maps of the Brooks Co. field [17 ha (42 acre)] created by the AgLeader and prototype Mississippi State University yield monitors. The field was used for variety trials with 29 varieties planted in four-row strips across the field.

Co. field (fig. 18) are particularly interesting because in addition to areas of low yield caused by erosion, yield difference resulting from the variety trials are also clearly visible as streaks of higher or lower yield.
